# Service Bulletin

MOTORCYCLE	
ISSUE NO.	: M-4-0507
DATE	: Mar. 10, 2010
PAGE	: 1 OF 3

SUBJECT	: CORRECTION OF SERVICE MANUAL
APPLICABLE MODEL	: VZR1800K6-K9, VZR1800ZK7-K9 and VZR1800NK8-K9
EFFECTIVE ENGINE OR FRAME NO.	:
REFERENCE	: E-02, 03, 19, 24, 28, 33, 51

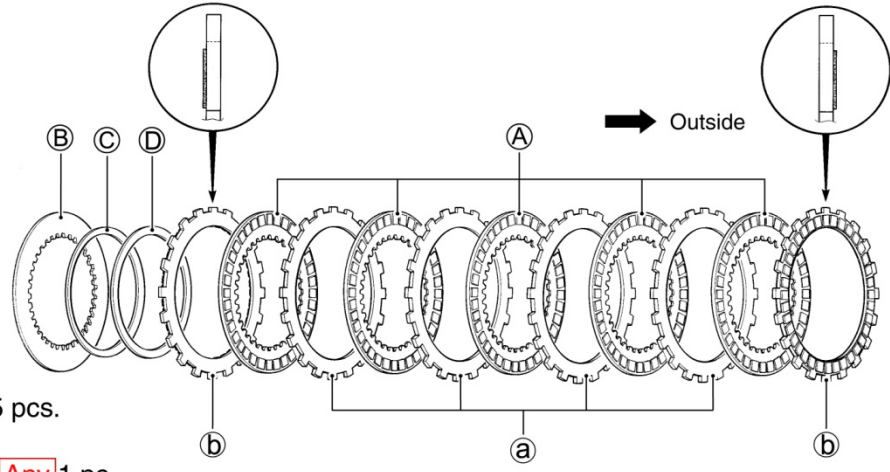
**DRIVE PLATE:**

- Ⓐ Drive plate No. 1 .....5 pcs.
- Ⓑ Drive plate No. 2 .....Any 1 pc.
- Ⓒ Wave washer .....Added
- Ⓓ Wave washer seat

**DRIVEN PLATE:**

- Ⓐ Driven plate No. 1 .....4 pcs. Added
- Ⓑ Driven plate No. 2 .....2 pcs.

**NOTE:**  
 \* Basically in this motorcycle, the drive plate No. 2 is installed as shown Ⓑ. Instead of the No. 2, however, sometimes the drive plate No. 3 or No. 4 may have been installed at the factory for the purpose of fine adjusting the overall thickness ① of clutch plates. When replacing the plate Ⓑ in the aftermarket, always use the drive plate No. 2.

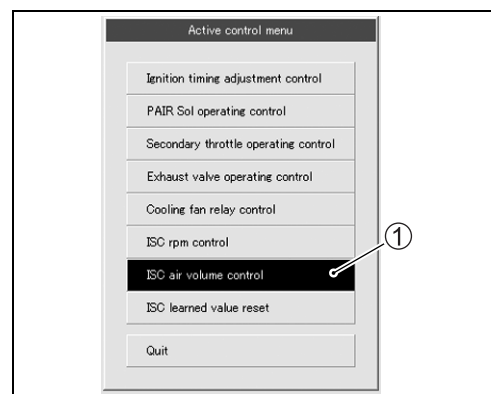
- ① Engine speed: Approx. 900 rpm
- ② ISC valve position: Approx. 30 step

- Click “Active control”.
- Click “ISC air volume control” ①.
- Click “ON” ② to fix the ISC air volume of two cylinders.

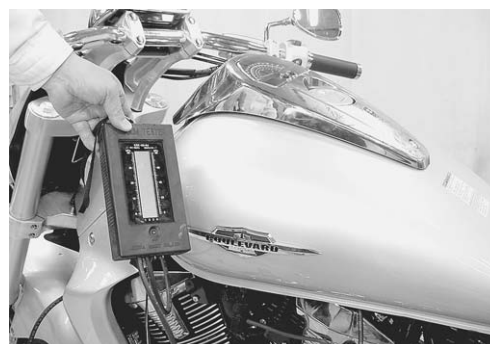
- Check the difference of vacuum between #1 and #2.

- Equalize the vacuum of the cylinders by turning each air screw ③ and keep it running at idling speed.
