# Service Bulletin

MOTORCYCLE	
ISSUE NO.	: M-4-0507
DATE	: Mar. 10, 2010
PAGE	: 1 OF 3

SUBJECT	: CORRECTION OF SERVICE MANUAL
APPLICABLE MODEL	: VZR1800K6-K9, VZR1800ZK7-K9 and VZR1800NK8-K9
EFFECTIVE ENGINE OR FRAME NO.	:
REFERENCE	: E-02, 03, 19, 24, 28, 33, 51

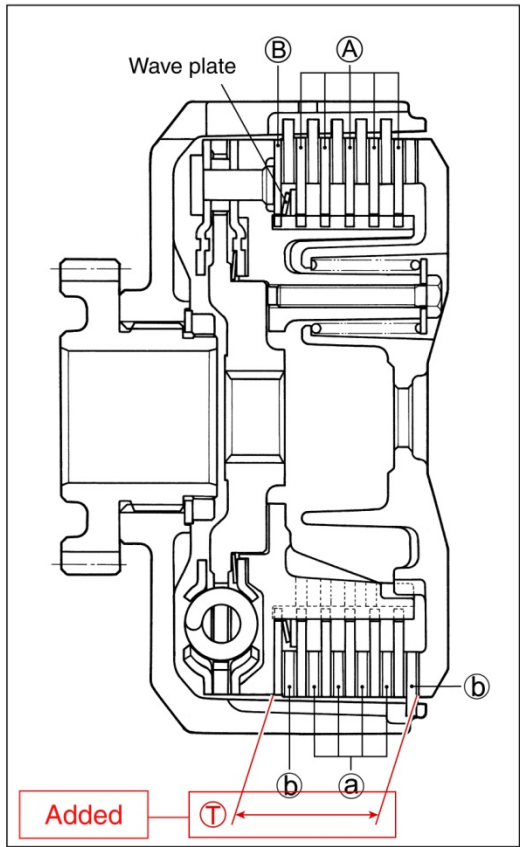
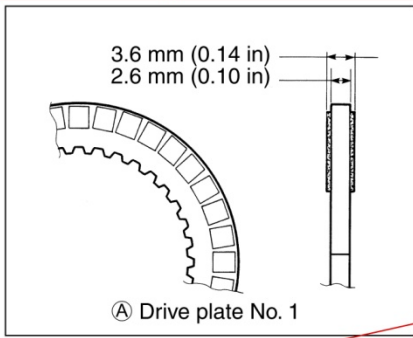
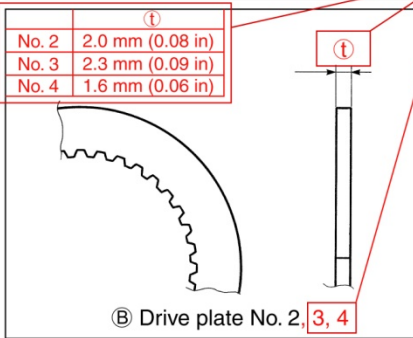
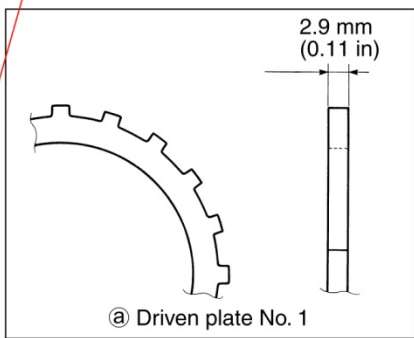
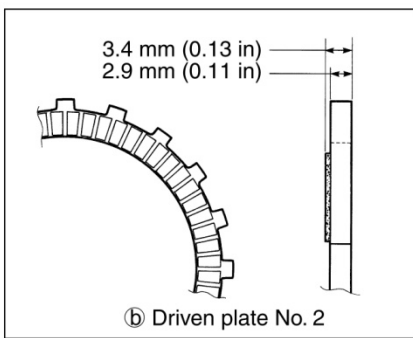
(drive plate No.2 - No.4 and driven plate No.1)

- Ⓐ Drive plate No. 1 .....5 pcs.
- Ⓑ Drive plate No. 2 .....Any 1 pc.
- Ⓒ Wave washer .....Added
- Ⓓ Wave washer seat

- Ⓐ Driven plate No. 1 .....4 pcs. Added
- Ⓑ Driven plate No. 2 .....2 pcs.

**NOTE:**  
 \* Basically in this motorcycle, the drive plate No. 2 is installed as shown Ⓑ. Instead of the No. 2, however, sometimes the drive plate No. 3 or No. 4 may have been installed at the factory for the purpose of fine adjusting the overall thickness ① of clutch plates. When replacing the plate Ⓑ in the aftermarket, always use the drive plate No. 2.

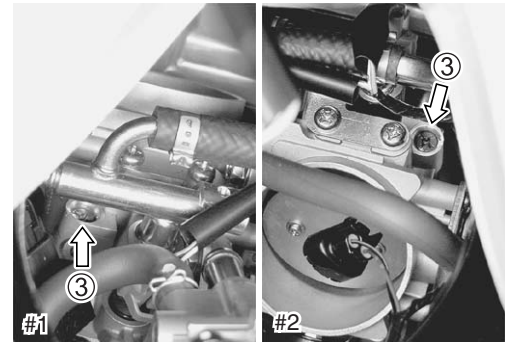
*\* Make a note of how many turns were made so the screw can be reset correctly after cleaning.*

- Repeat the procedures of Step 2.
- Disconnect the vacuum tester and install the removed parts.
- After completing the throttle valve synchronization, clear the DTC using SDS tool. (☞ 5-26)
